## Ryesgade 30 A-C

Extra layer of glass on the inside

## Windows

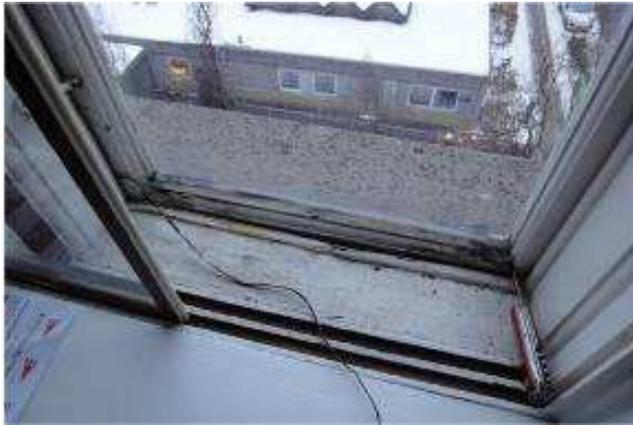
Before renovation the windows gave rise to condensation, draught and had a very negative effect on the indoor climate. Source: "Resultater og erfaringer fra energirenovering af Ryesgade 30", Source: Leif Rönby

Original preservation worthy wooden windows from before 1950-60 with one layer of glass can be energy improved by adding a coupled frame with low energy glazing internally. If the window already has a coupled frame, energy improvement can be achieved by replacing the glazing in the coupled frame with new low energy glazing. Alternatively, new coupled frames can be made with room for low energy glazing. Windows with initial signs of degradation should be completely refurbished or replaced with new windows with coupled frames and energy glazing. Alternatively, the windows can be replaced by new ones taking into consideration the architecture of the house. If the window has no coupled frame to begin with, this would be considered a medium impact solution.

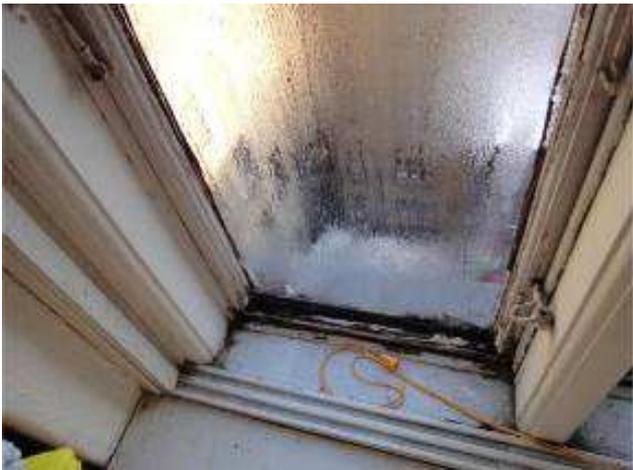
Before renovation the windows gave rise to condensation, draught and had a very negative effect on the indoor climate. Source: "Resultater og erfaringer fra energirenovering af Ryesgade 30", Source: Leif Rönby
