## Freihof Sulz

Author: Dagmar Exner (Eurac)

Addition of foils or coatings to the glass

## Windows

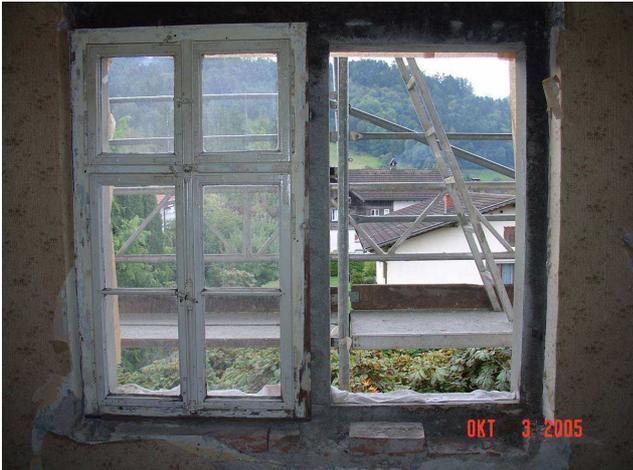
Window solution at Freihof Sulz before (middle above) and after renovation (box-type window), © Beate Nadler-Kopf

Renovation of ecological “Freihof Sulz” (Vorarlberg, Austria): Holistic redevelopment of the listed building into a lively meeting place. Due to the protection of historical monuments (see link to pdf below: a special feature (of the building) are the windows with largely cambered glass, shutters and sandstone frame) and well-preserved cambered windows, the decision was made to retain the box-type windows. Repaired and replaced using old wood material parts that were rotten, fell off or were infested with pests. New wood was used for large, damaged areas. Holes were filled in; irregularities were sanded or puttied. Old varnish was sanded off, the oil rubbed off with spirit. The windows were glazed out, the old putty was removed. With a special tool, only loose spots were sanded and then patched because otherwise, the paint would not have adhered. Afterwards, they puttied with linseed oil putty. The renewed glass was coated with a low-E coating. Partly the glass was re-glazed. In the listed rooms on the ground floor, the old, cambered glass was used. The fittings were rubbed off and after a function check they were lubricated and set up. Windows were partly machined at the bottom with a planing machine to ensure tightness. Glazing was done without silicone, instead, oil glue putty was applied with a spatula. Weather shanks were removed, and new ones made of larch wood were fitted. For sealing, sheep's wool was stuffed from the outside and grouted with acrylic. Inside, the carpenter sanded, puttied and patched the frames and checked and reattached the fittings. In some cases, holes had to be drilled on the sides and the frames screwed to the masonry. Shutters are designed to match the sunlight. Depending on the floor, direction and use, the shutters are partly closed at the bottom and are equipped with fixed slats or adjustable slats for display. Shutters were partly in very bad condition. They were also repaired as described above.

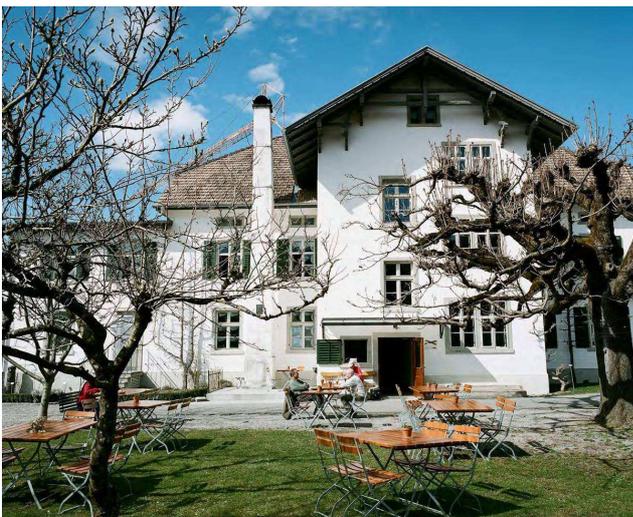
Window solution at Freihof Sulz after renovation (box-type window), © Lukas Schaller

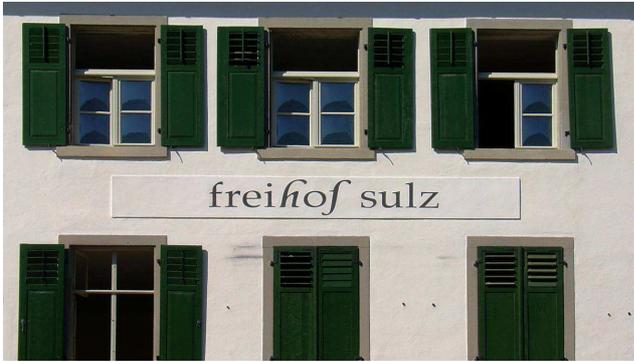
Window solution at Freihof Sulz after renovation (box-type window), © Lukas Schaller

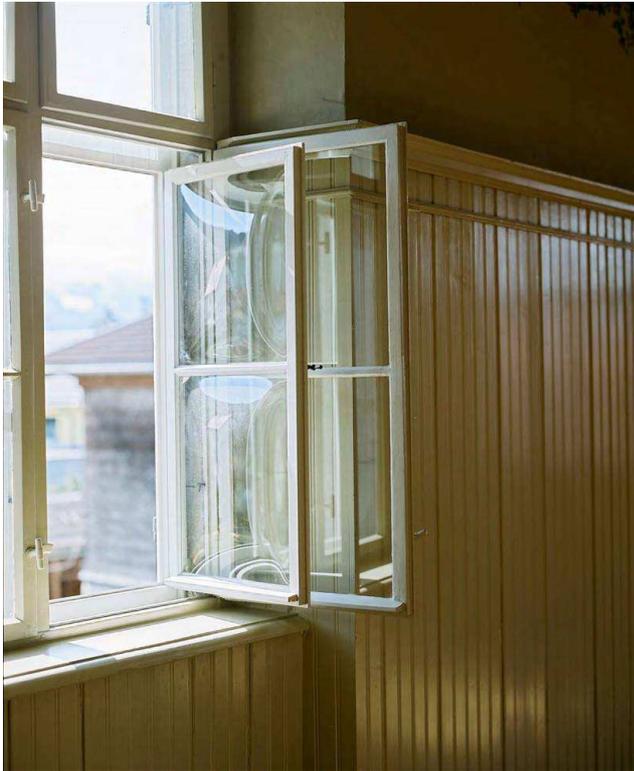
Window solution at Freihof Sulz after renovation (box-type window), © Lukas Schaller

Thermal properties	Existing window	Refurbished window
Window type	Box-type window	Box-type window
Glazing	Two single glazing as box-type windows	Two single glazing as box-type windows with low-e
Shading	Outer shutter	Outer shutter
U <sub>w</sub>	2,2	1,8
U <sub>g</sub>	2,0	2,0
U <sub>f</sub>		0,7
g-value glass		2006
Approximate installation year	1900
