## Ansitz Kofler

Author: Alexandra Troi (EURAC), Eleonora Leonardi (EURAC)

Airtightness thanks to detailed planning and vapour retardant layer – Solution B

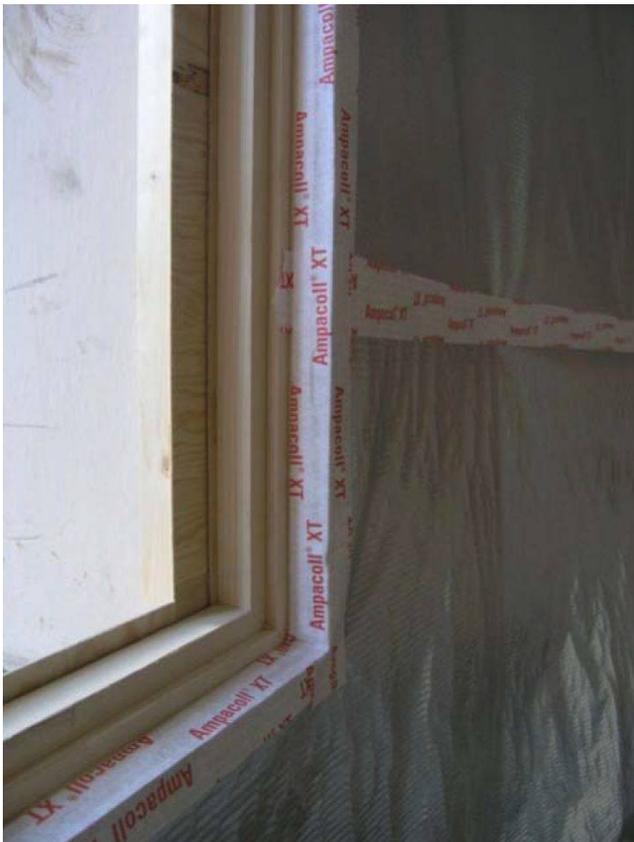
Air-tight connection to the window frame  
(c) Manuel Benedikter

To reach a continuous air-tight layer at Ansitz Kofler, the vapor barrier on the walls was (i) well connected to the vapor retarder on the roof, (ii) turned around the border of the lean concrete in the floor, and (iii) well connected with tape to the window sub-frame and other openings. All electric and hydraulic ducts and cables were installed on the inner side of the vapor barrier in order to prevent punctures. To check the tightness of the vapor barrier and to discover any leaks, a preliminary blower door-test was done before the application of wooden battens and plaster boarding. The final Blower Door test following European Standard UNI EN 13829, procedure B, resulted in a very good value of  $n_{50} = 0,66/h$  (for comparison: 0.6 needed for PH certification, 1.0 for EnerPHIT). The new windows are obviously also part of the measures to guarantee airtightness. Details on the connections can be found in the External Wall sections and the windows of the best practice example "Ansitz Kofler".

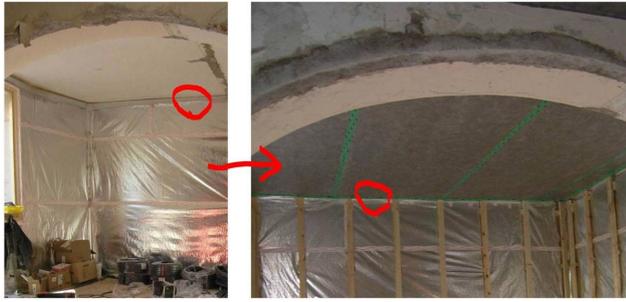
Vapour barrier on the walls and its connection to the vapour retarder in the ceiling (c) Manuel Benedikter

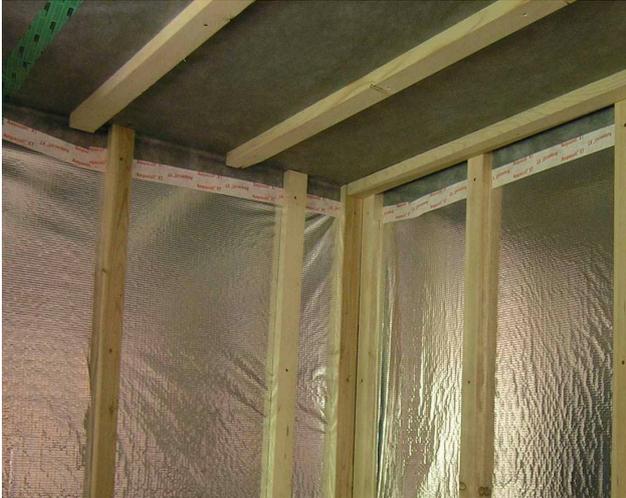
Battens for installation layer, which avoids penetrating the vapour barrier with pipes and cables (c) Manuel Benedikter

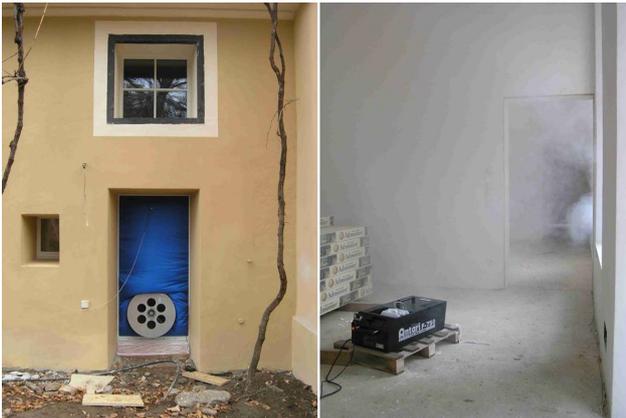
Blower Door test with smoke test, done during construction phase (c) Manuel Benedikter

Blower Door Test and comprehensive documentation of the overall intervention in the master thesis of Hannes Mahlknecht (attached)

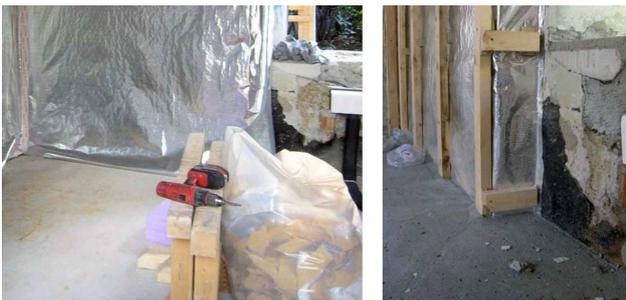
Air-tight connection thanks to concrete screed on the floor (c) Manuel Benedikter
