## Gasthof Adler Langenegg

Mineral Wool under shingle facade

### Walls

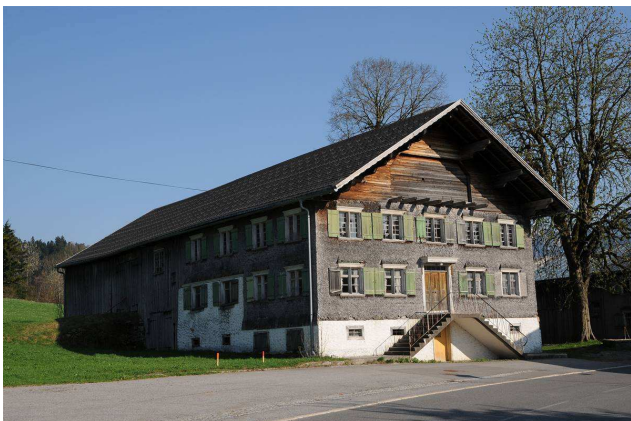
Photo of the building before the renovation,  
©EIV

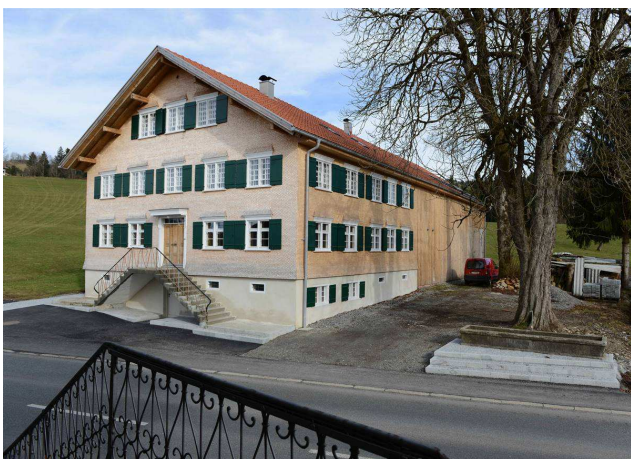
Photo of the building after the renovation,  
©EIV

The appearance of the historic building is preserved by placing the outside

insulation layer behind the shingle façade. This measure resulted in an improvement of the U-value from 0,56 to 0,28 W/(m<sup>2</sup>K). A point against this solution could be the completely replacement of the old façade, but in many cases, this is necessary to guarantee the driving rain protection of the building. The renovation of the external walls leads to a reduced energy demand of the building but also an increased risk of moisture due to the higher airtightness of the building. Therefore, a vapor control layer of low-medium resistance should be installed. Also, a strong vapour barrier would inhibit any inward drying of the original timber. This solution with the external insulation in general is a robust solution to prevent condensation in the wall.
