Only repairing window

Author: Élodie Héberlé (Cerema)

Windows

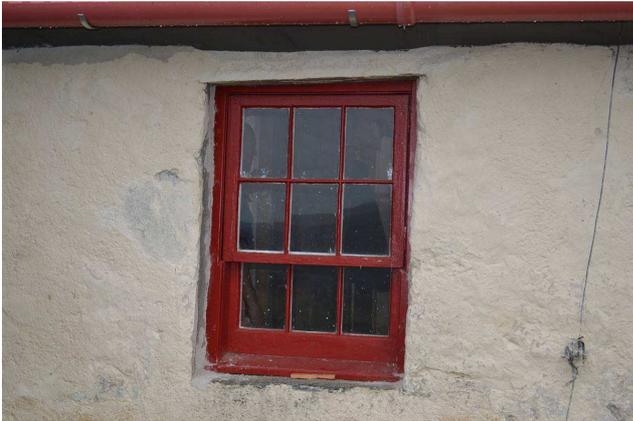
Single window after repairing, © HES

In Downie's Cottage, the windows were removed and cleaned and carefully renovated down back in the workshop. Due to their small size, thermal improvements were not deemed to have been effective.

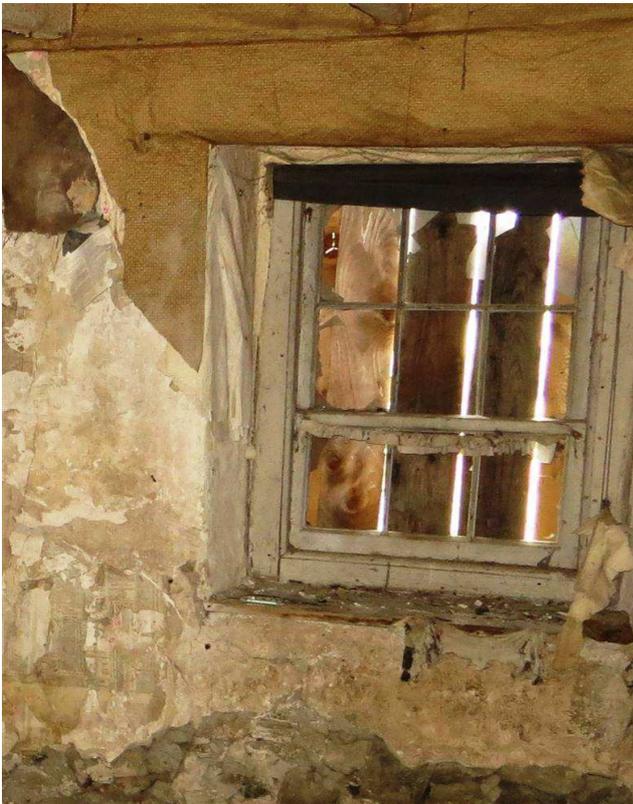
Single window before repairing, © HES

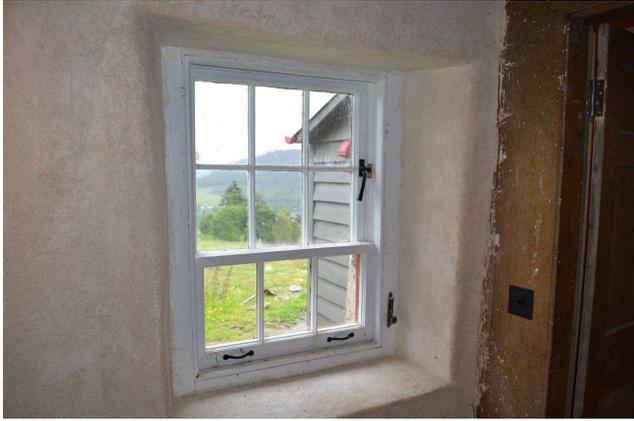
Single window before repairing, © HES
