Thomas Laubs Gade

PUR-foam with channels of capillary-active material
– solution A

Walls

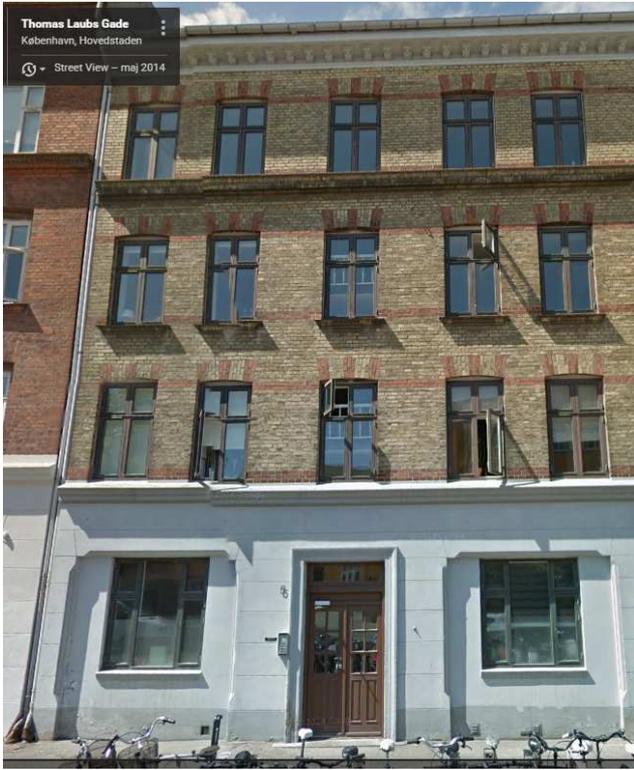
PUR –foam-based internal insulation of external walls. 30 mm PUR-foam based insulation ($\lambda 0,031 \text{ W}/(\text{m K})$) applied to 350 mm solid masonry walls, at the interior side. The insulation consists of PUR-foam with thin calcium silicate channels every 40 x 40 mm, making the insulation capillary-active to some extent. Any irregularities in the original inner surface (render) are levelled by means of plaster and glue mortar before applying the insulation blocks.

Cross section of the wall build-up, available pictures of the solution:

This solution does not change the expression of the building seen from the outside. In a specific case (multi-storey residential building), measurements at the interface between the existing wall and the internal insulation show a decrease in relative humidity so that after about 6 months there is no risk of

mould growth. The calculated U-value of the wall was reduced from 1,49 W/(m² K) to 0,59 W/(m² K) with 30 mm insulation. There was no measurement of energy consumption before and after the renovation.

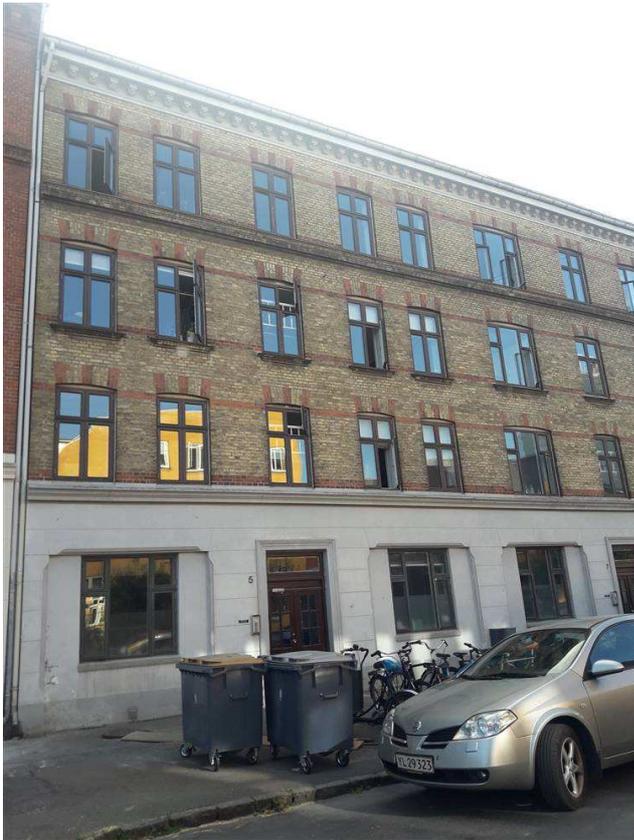
© AAU

Facade towards street. External wall in apartment at upper floor was renovated with internal insulation. © Google street view
