Folehaven

PUR-foam with channels of capillary-active material
– solution B

Walls

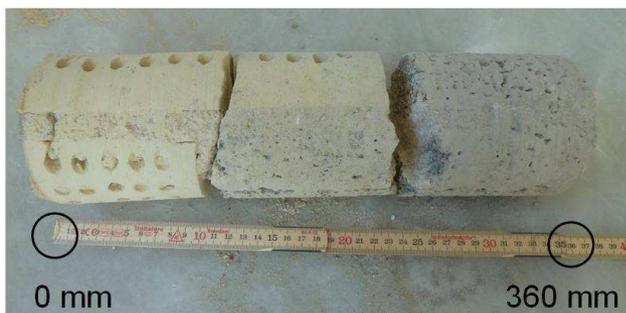
Drill core of the wall structure. © AAU

Internal insulation of 360 mm solid gable walls made of brick and lightweight concrete (110-230 mm outer layer of brick with holes, layer of concrete, and 10 mm interior plaster) using 80 mm PUR-foam ($\lambda 0,031 \text{ W}/(\text{m K})$) with thin calcium silicate channels every 40 x 40 mm, making the insulation capillary-active to some extent. Any irregularities in the original inner surface (render) are levelled by means of plaster and glue mortar before applying the insulation blocks. The average U-value of the wall is reduced from $1,05 \text{ W}/(\text{m}^2 \text{ K})$ to $0,65 \text{ W}/(\text{m}^2 \text{ K})$ (calculated values).

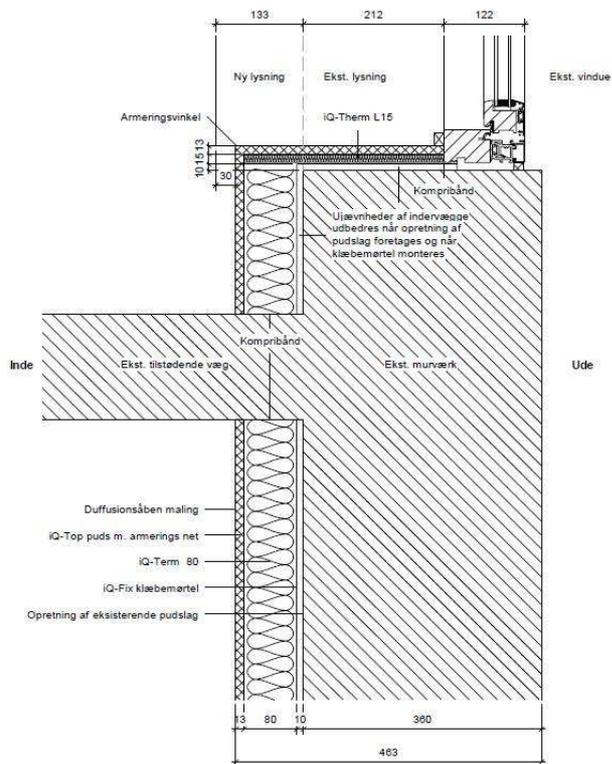
Internally insulated gable wall, 80 mm of insulation (PUR-foam with thin calcium-silicate channels). Horizontal cross-section between external wall (insulated) and internal wall, including details at window (window sill insulated). © AAU

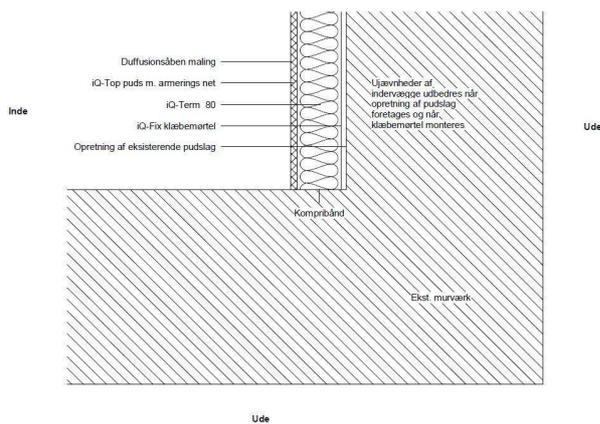
Internally insulated gable wall, 80 mm of insulation (PUR-foam with thin calcium-silicate channels). Corner between gable wall (insulated, at right) and facade (not insulated, at bottom), horizontal cross-section. © AAU

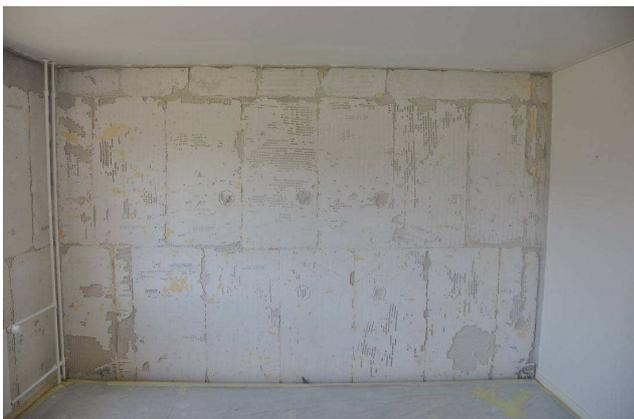
View of gable wall after removing the internal insulation, to look for mould growth two years after installation. No mould growth was identified, however the view shows that the insulation system did not fully bond to the existing wall. © AAU

applying the insulation system to remove any remains of organic material before its installation. Wooden laths were applied at the inner surface to give the inhabitants the possibility to hang paintings or other things on the walls without damaging the insulation. In some of the test apartments, the insulation was removed again after two years to see whether there was any mould growth at the interface between the insulation and the original wall.

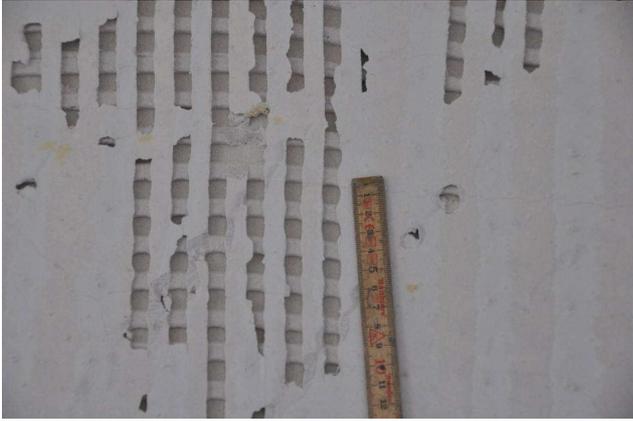
Close up of the wall showing the size of the areas with no bonding. According to the producer, opening of max 4x4 cm are accepted © AAU

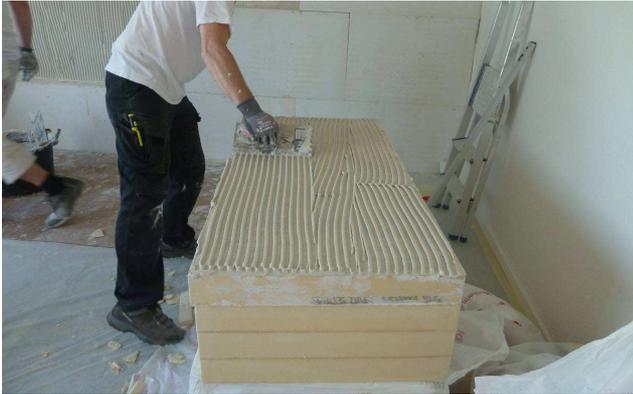
Installation of internal insulation © AAU
