## Replacing outer glass (includes vacuum and insulation glazing)

### Windows

Holyrood Park Lodge is a Category B listed Victorian lodge building built in 1857 in a neo-gothic style, located in a prominent position at the entrance to Holyrood Park in Edinburgh. Primarily designed for the constables who policed the Royal Park, it is bounded by the Palace of Holyroodhouse on one side and the Scottish Parliament on the other. Since 2007 the lower floor hosts visitor information and shop center for the Holyroodhouse area.

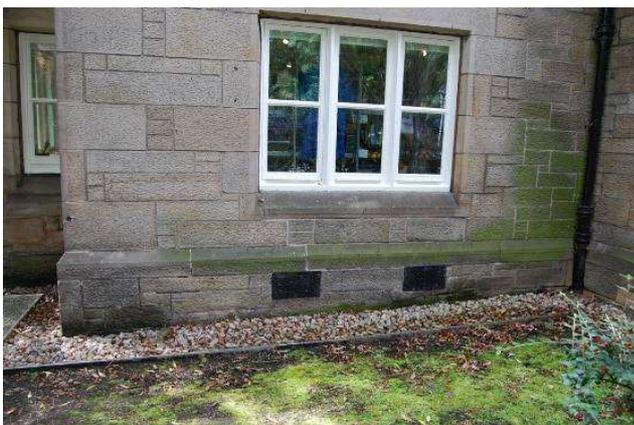
New windows seen from the outside. Image: Historic Environment Scotland.

In Hollyrood Park Lodge the frame of the existing windows was in good condition and therefore the decision was made to keep them. The glazing was replaced by new slim-profile double-glazed units, which significantly improved the energy characteristics of the windows without changing notably the appearance. The U-value is reduced by approx. 70% while the new glazing also improves the indoor climate by removing draughts.

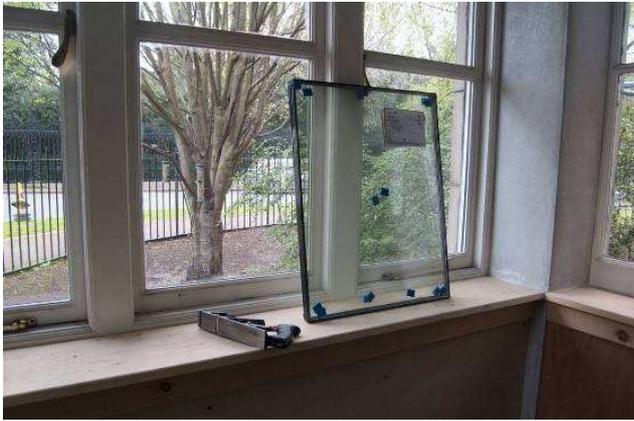
New glazing units added to Holyrood Park Lodge. Image: Historic Environment Scotland.

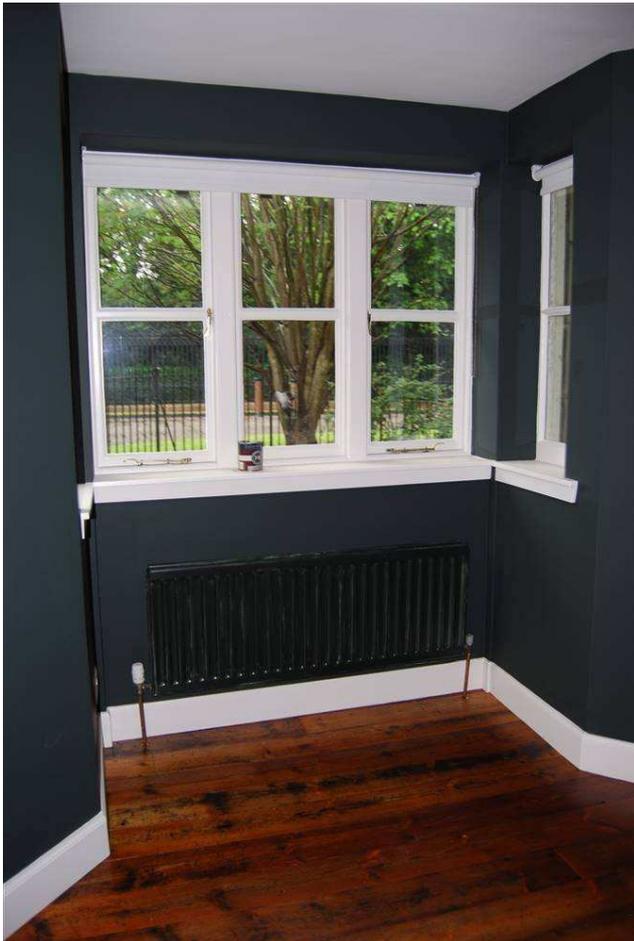
New windows seen from the inside. Image: Historic Environment Scotland.

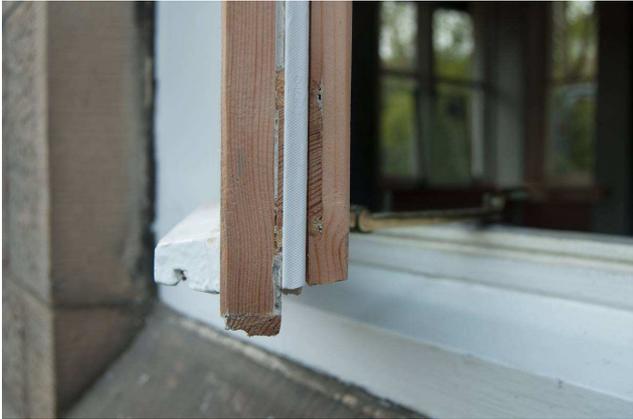
HPL Draught stripping
