House Moroder

Replacing the window

Windows

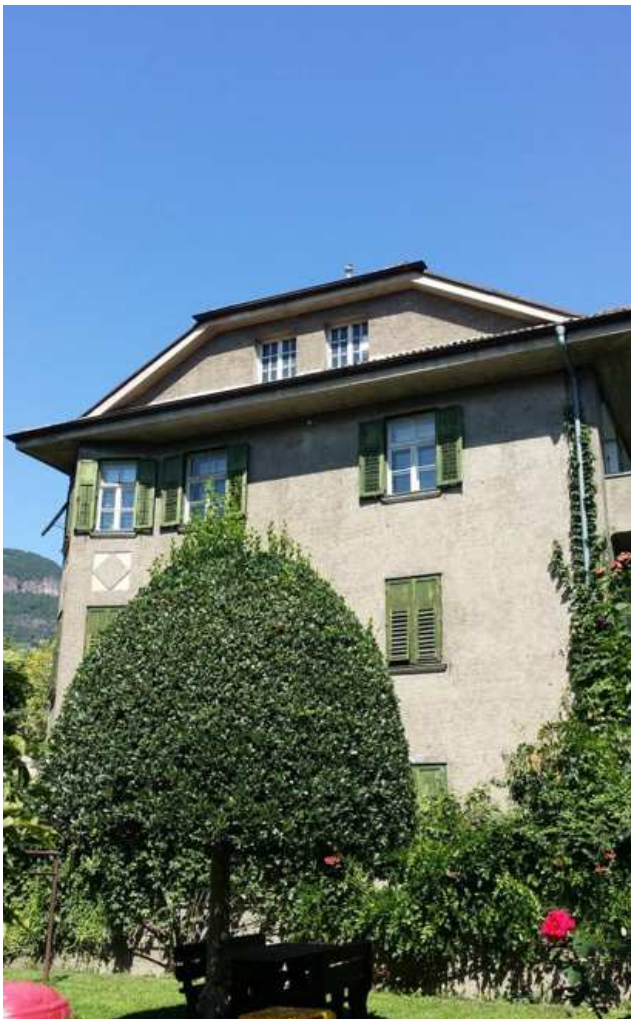
Windows before renovation

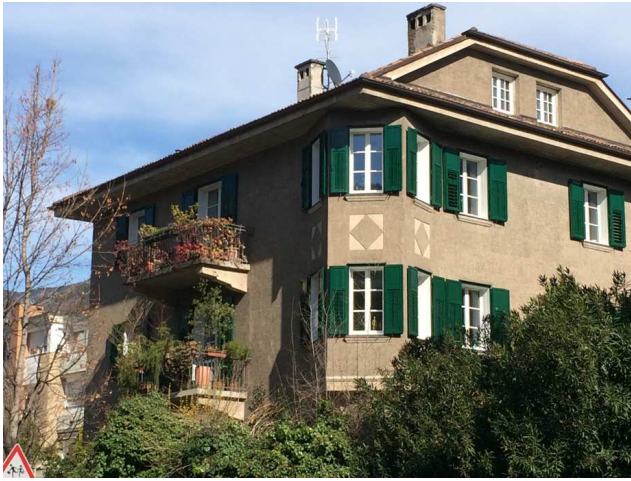
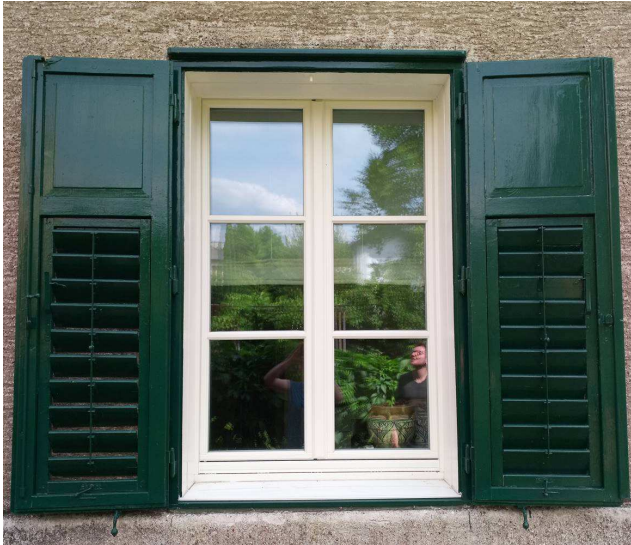
Windows after renovation

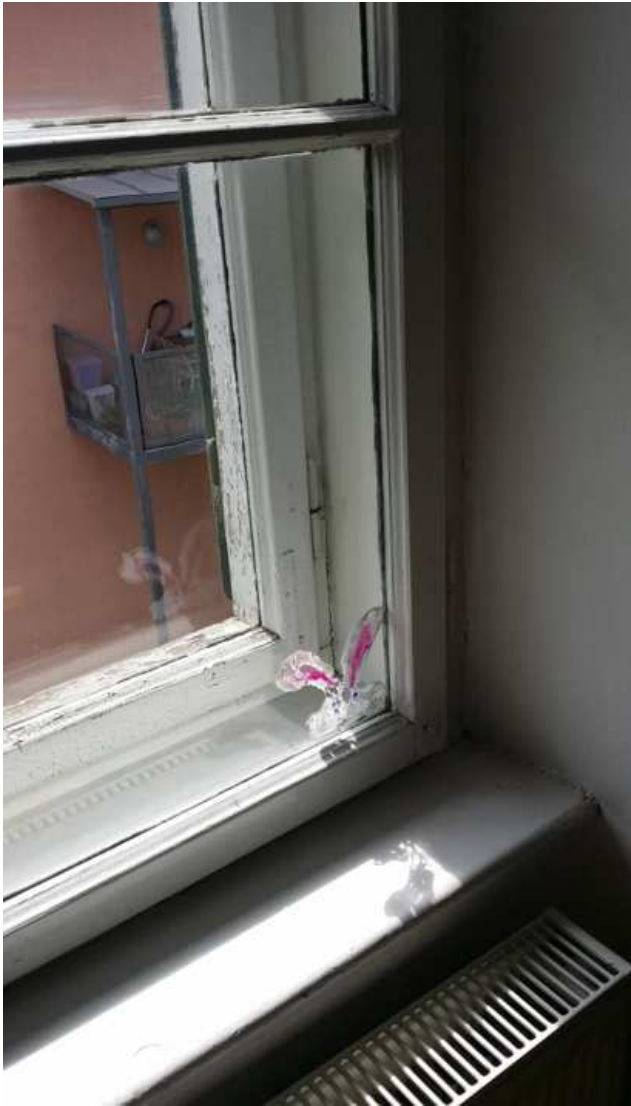
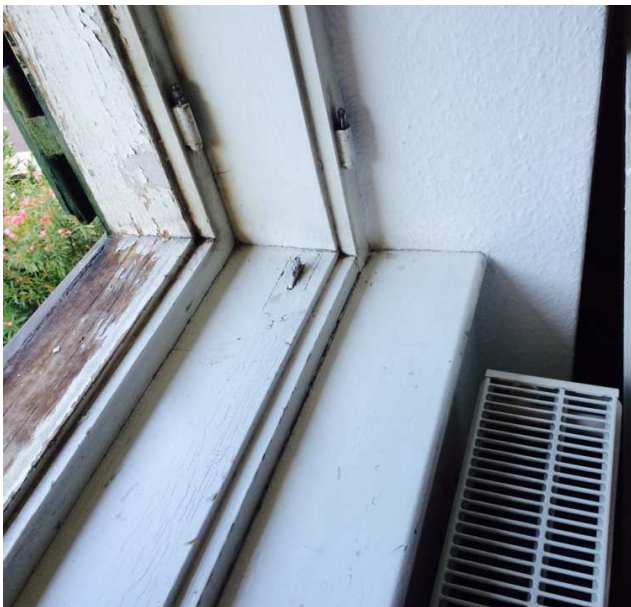
Window details before renovation

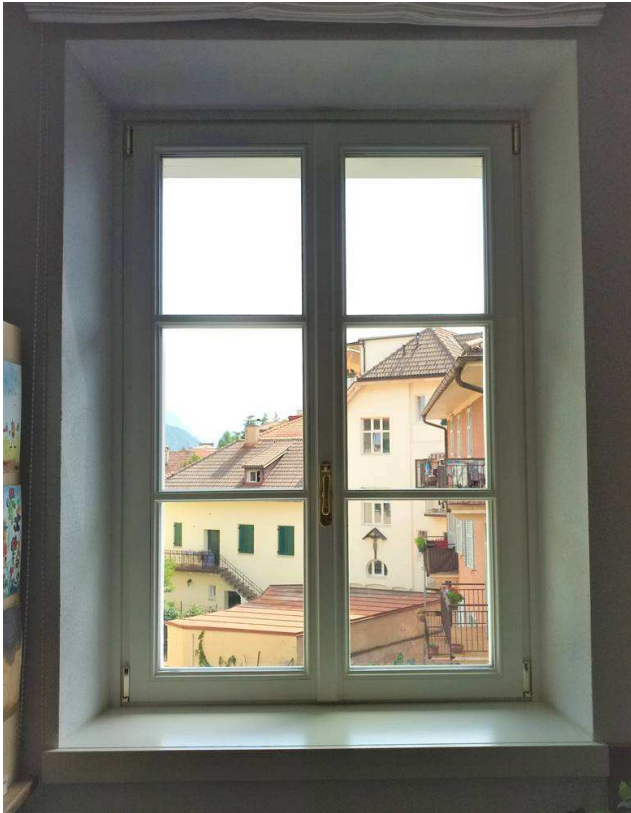
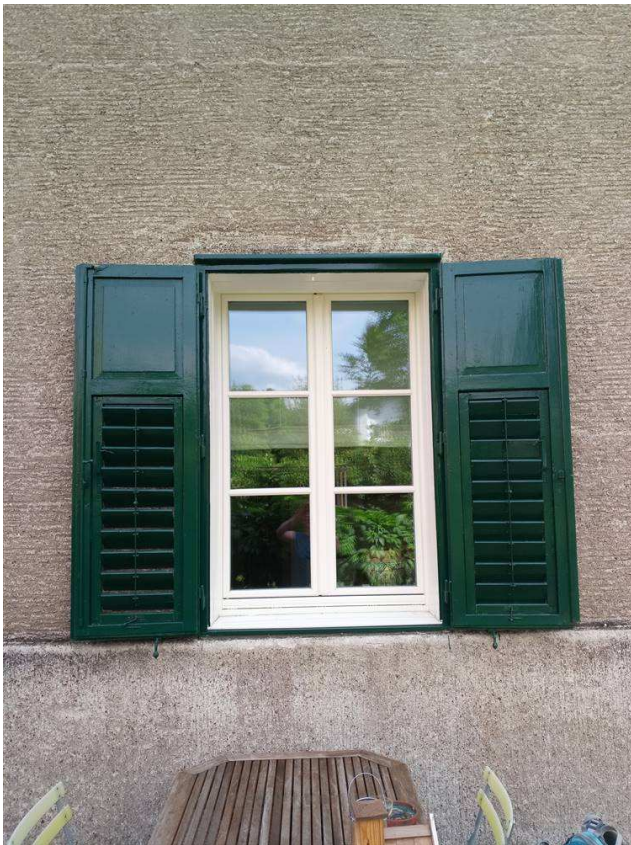
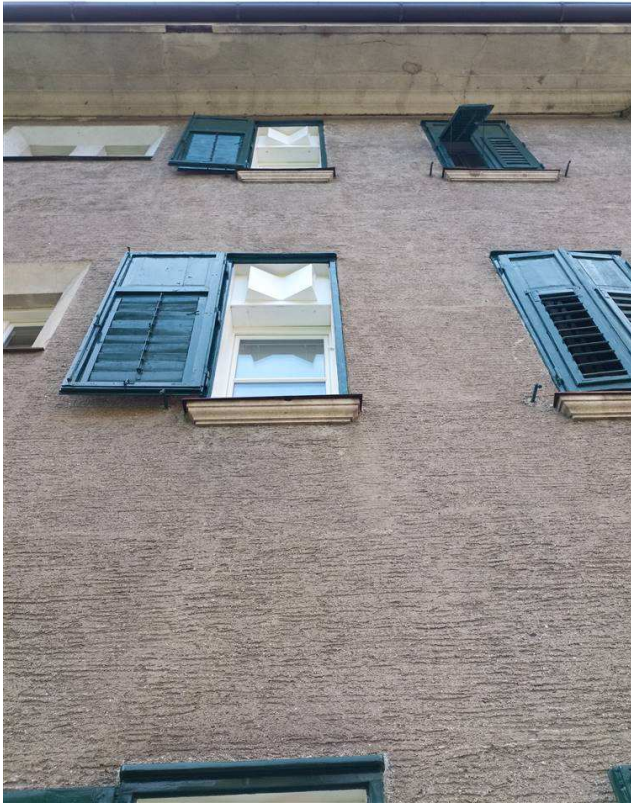
Window after renovation

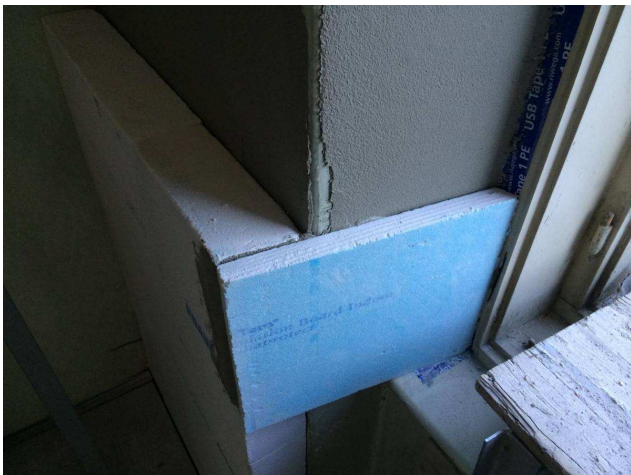
Internal insulation at the window reveal

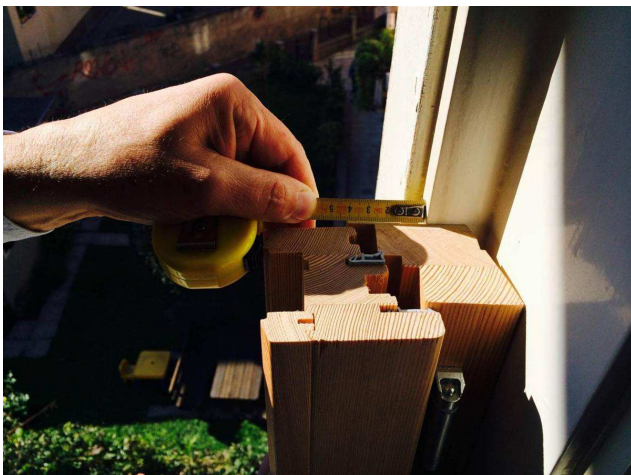
Connection of new window to existing frame

removal of the old box-type windows and the installation of new triple-glazed windows with a special focus on the connection of the new window to the existing window frame (see detail drawing).

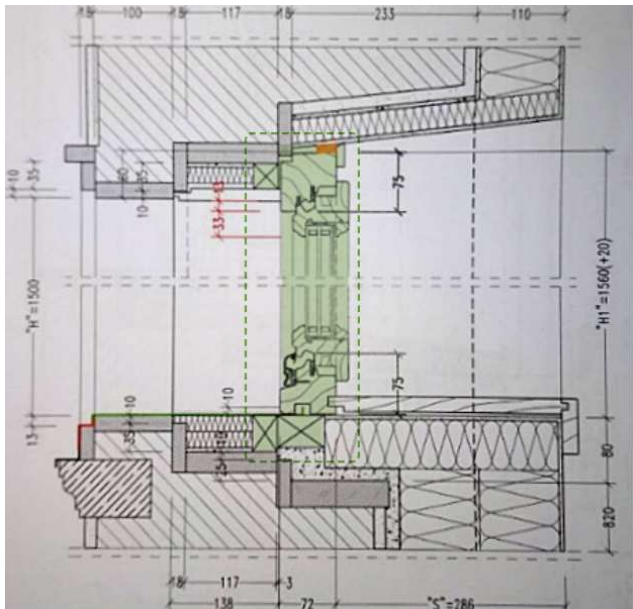
Window detail

Thermal properties	Existing window	Refurbished window prototype
Window type	Box-type window	Single window
Glazing	Inner window: single glazing Outer window: single glazing	Triple glazing (4-12-4-12-4 mm)
Shading	Existing window shutters	Existing window shutters
U _w	-	1,13
U _g	-	0,7
U _f	-	-
g-value glass	-	0,49
Air tightness	-	2-fold sealing
Approximate installation year	1926	2015
