Replacing the window sash or window layer (on the outside)

Author: Élodie Héberlé (Cerema)

Windows

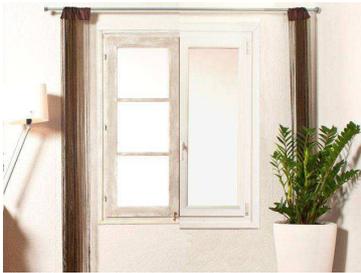
This solution consists in replacing the sash of an existing single window, while the existing frame is not affected. It is a middle impact for both heritage and energy, especially if the existing single window was repaired before the replacing of the sash. In the case of box-type or coupled windows, another solution is to replace the outside window layer.
