## Kildonan

Wood fibre board between frames, calcium silicate board onto masonry

## Walls

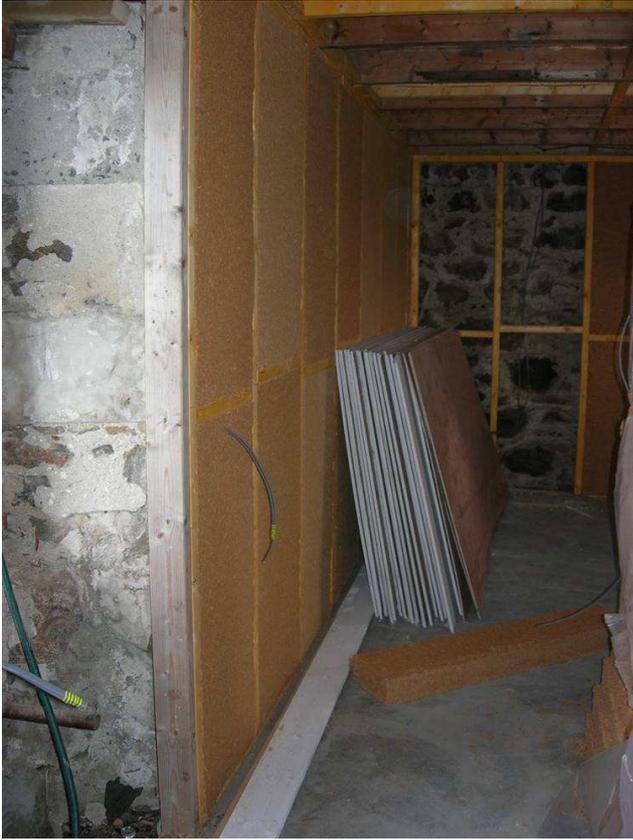
A finished wall with the wood fibre board insulation © HES

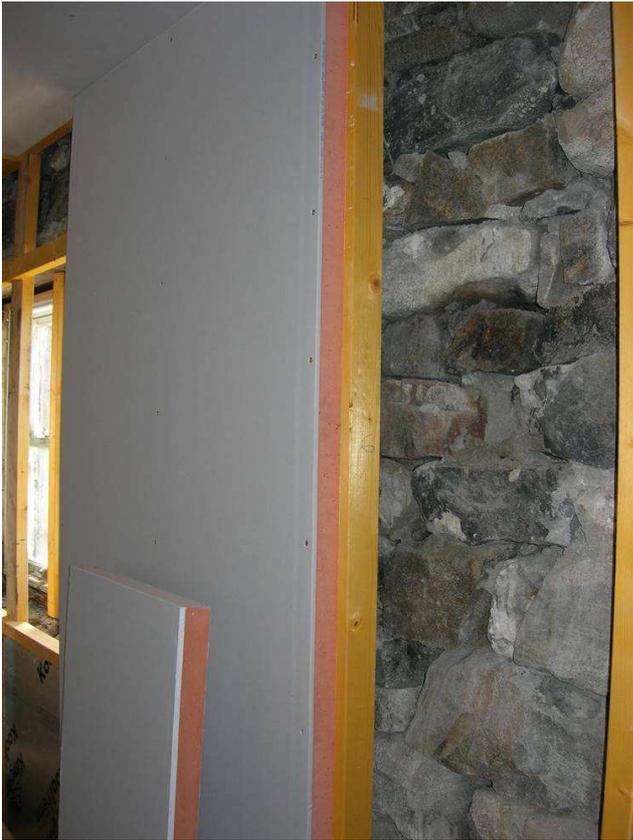
The thickness of the wood fibre insulation against the whinstone wall © HES

This solution was only suitable where there are no historically significant interior decorations on the wall. The materials are vapour and capillary active and allow the moisture transfer through the walls, even without an air gap. The wood fibre insulation has a thickness of 100 mm and improved the U-value from  $2,1 \text{ W}/(\text{m}^2\text{K})$  to  $0,4 \text{ W}/(\text{m}^2\text{K})$ . Since wood fibre board is not completely vapour open, it is important to consider the impact of driving rain and similar high moisture scenarios. The calcium silicate board has a thickness of 50mm, with a lambda value of  $0,059 \text{ W}/\text{mK}$  and reduced the U-value to  $1,0 \text{ W}/(\text{m}^2\text{K})$ .

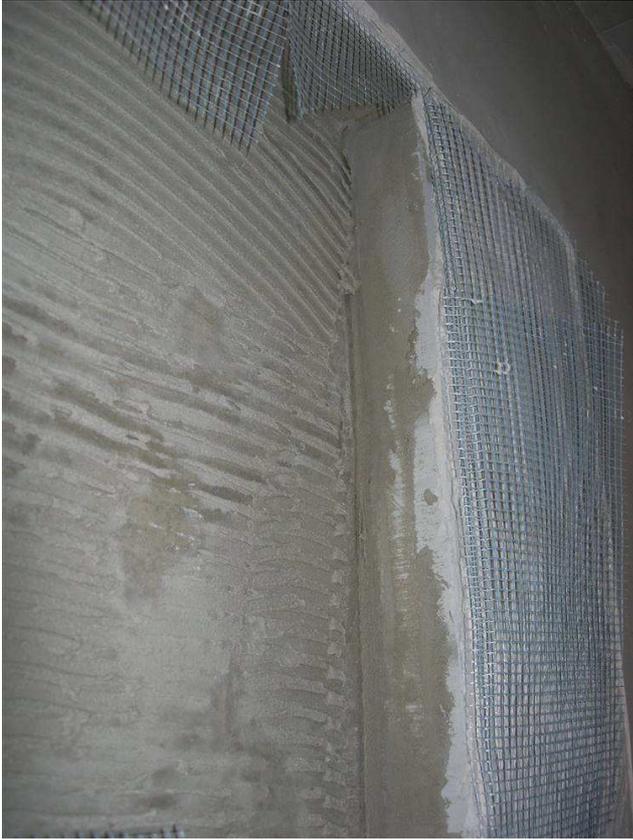
The thickness of the calcium silicate board  
© HES

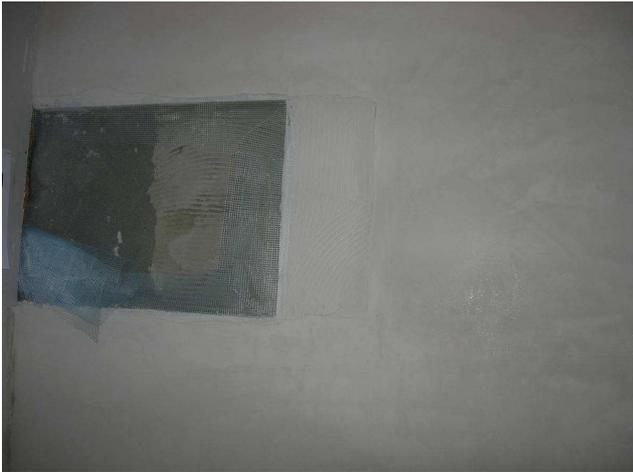
The almost complete wall insulated with  
calcium silicate board © HES

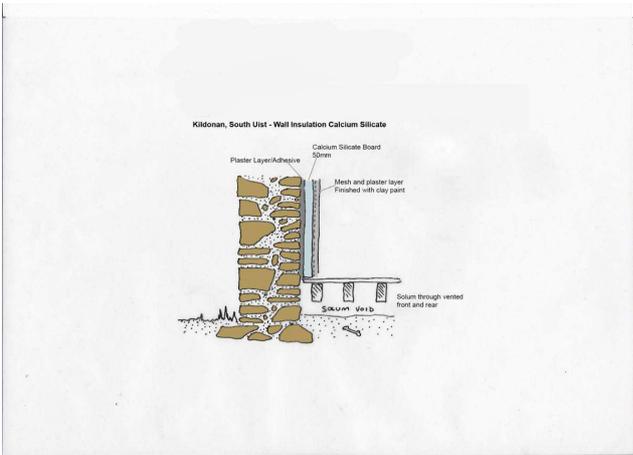
Indicative diagramme for the calcium  
silicate board © HES
