Annat Road

Injected foam insulation behind existing plaster

Walls

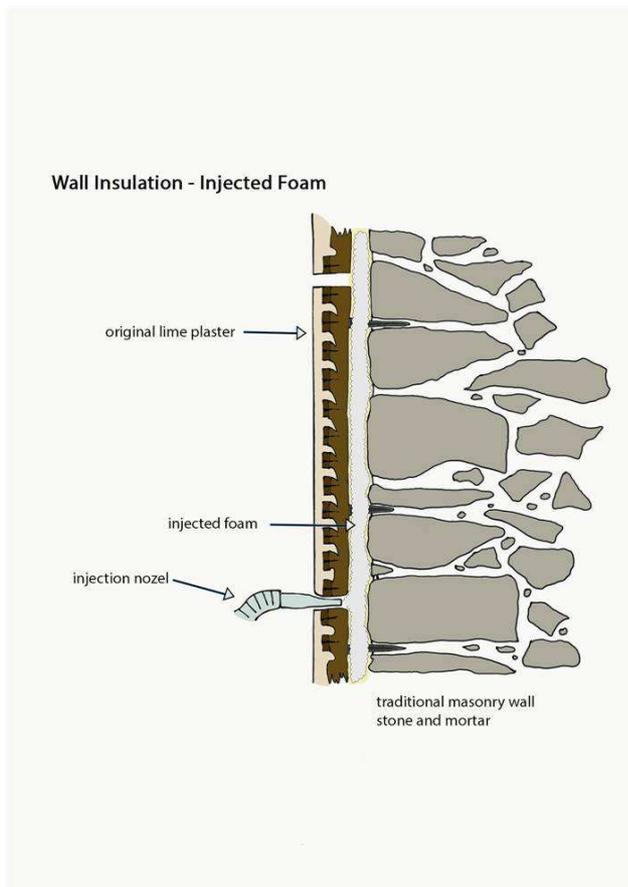
Indicative diagram showing the foam being injected behind the lath and plaster lining © HES

This measure is a water based foam injected behind existing lath and plaster. The method retains the existing traditional finish in the building and adds an insulation layer between the wall and the plaster finish.

While the width of the gap is modest, around 40mm, the water based foam is able to fill the void effectively. The cured foam is vapour open and capillary active, minimising the risk of condensation damage. The post intervention U value was 0.7 - see the case study for full details

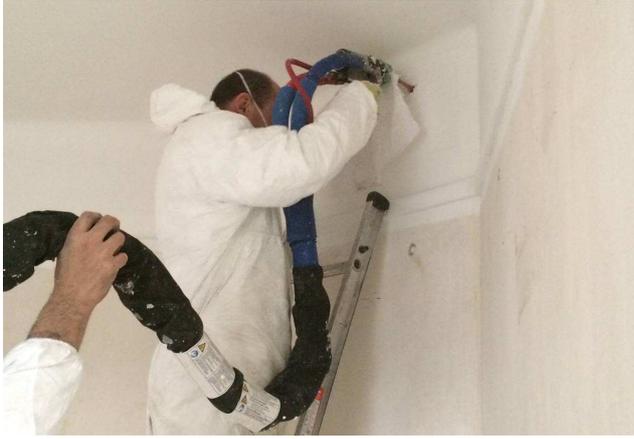
Photograph showing the injection of the insulation foam © The Gannochy Trust
