Half-timbered house in Alken, Belgium

Wood fibre boards and internal mineral wool insulation

Walls

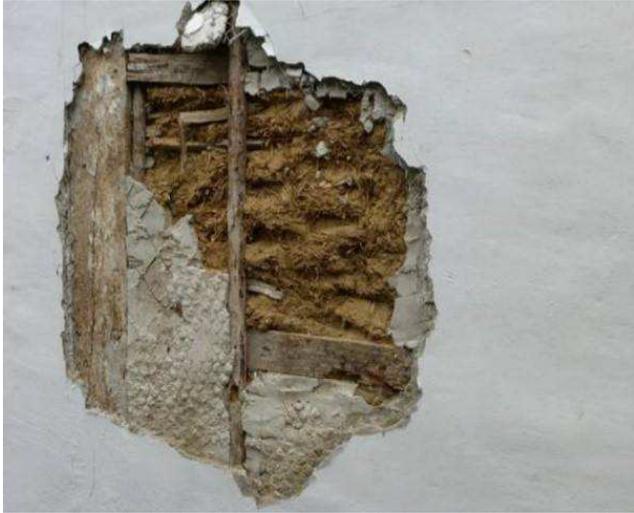
Details of the original wall composition with wooden fence, visible wickerwork and loam (copyright Erfgoed en Visie bvba)

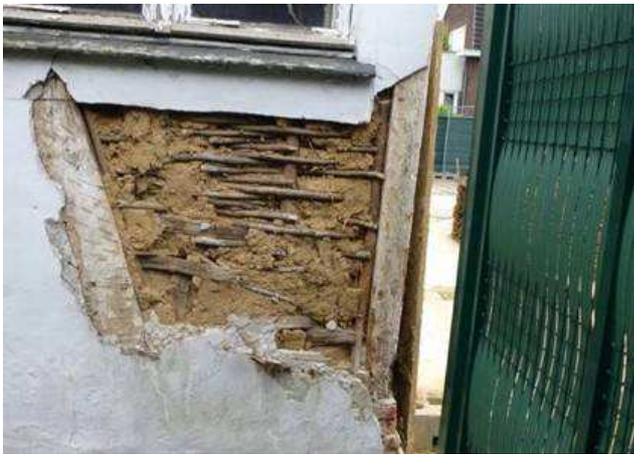
Original wall build-up (outside to inside)	Layer	Material	Thickness	Finishing
	Outermost	Rendered	2-4 cm	finishing: loam
	Layer 2	Other	10-14 cm	filling of framework structure: loam + wooden fence
	Layer 3	material	thickness	
	Layer 4	material	thickness	
	Layer 5	material	thickness	
	Layer 6	material	thickness	
	Innermost	Plastered (or)	2-4 cm	finishing

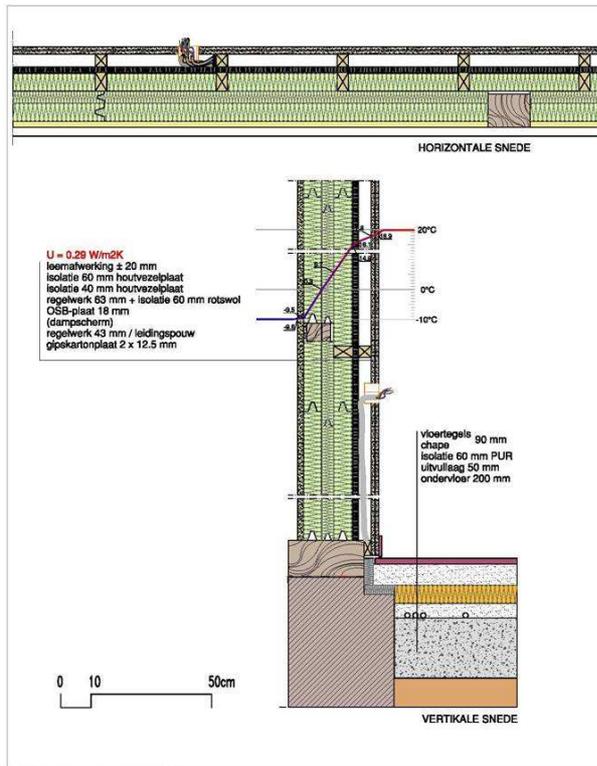
Cross-section for the retrofitted wall insulated with wood wool fiberboards and mineral wool

VAKWERKBOUW - wandopbouw

schaal 1/10

The solution consists in insulating a timber-framed wall (wooden truss, loam and wickerwork) with a combination of wood wool fiber boards and a clay plaster finish in the framework and a retention wall with mineral wool insulation at the interior side. A pipe -service -pillar was provided on the inside. The visual perception of the wall seen from the exterior has not altered. The truss structure is not visible on the inside of the wall. The modifications made to the wall in function of energy-efficiency were approved by the conservation authority. Different scenarios where possible for the filling of the wooden truss: 1.) re-installation of the traditional wickerwork and loam, with or without extra insulation from the inside 2.) filling the compartments with wood fibre insulation boards or wood wool 3.) a filling with lime hemp blocks The first scenario was not chosen because the fear of high maintenance, concerns about insulation values and the labour-intense and therefore expensive installation. The third scenario was a plausible solution, but the architect chose the second scenario (wood fibre board is less expensive and easier to handle than hemp blocks). The steps described in the restoration file were the following: tensioning and bracing of the truss structure, after which the half timbering could be repaired, cleaned, restored and treated. For the replacements of deteriorated or damaged parts, the same type of wood (oak) in the same dimensions would be provided. After this the insulation of the truss structure

could be executed by filling in the boxes with wood fibre insulation boards, and an extra wood fibre board, to be finished with a render.

During execution the restoration plans where changed. The wood fibre insulation board that was provided on the inside was replaced by a retention wall, filled with rock wool insulation. The main purpose of the change of the intervention was extra acoustic insulation. As a result the thickness of the façade package has increased considerably and the truss structure is no longer

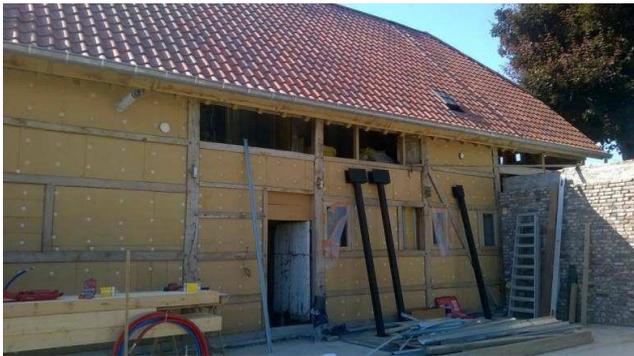
Rear wall of the half timber-framed house in Alken during intervention
