Crichton Castle

Author: Anne Schmidt and Roger Curtis (Historic Environment Scotland)

Free standing Photovoltaic System

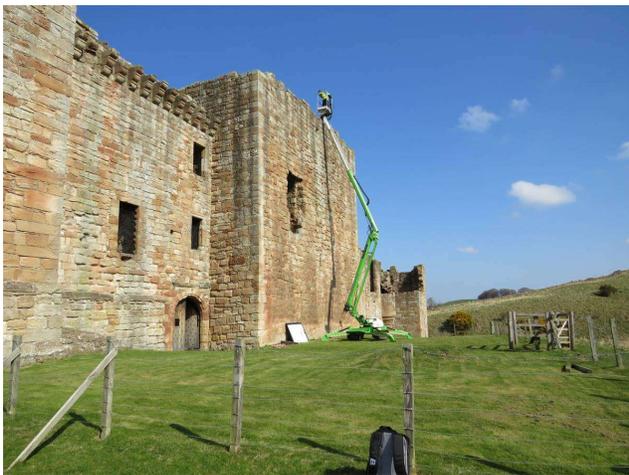
Installation of the PV panels © HES

The panels were mounted on the roof of the castle, mechanically fastened to a modern flat roof. Due to the parapet of the ruin still being quite high, the panels could not be seen from the ground. Historic fabric was not affected by the installation. Scheduled Monument Consent was required for this installation, but as it had no effect on the historic fabric that was granted back in 2005, and again for the new panels in 2019.

The new panels replaced ones first installed in 2005. This has proved to be reasonably simple to do, although crane access was needed to get the panels up. Existing power cabling was used, o no disruption inside the monument, and similar fixing points on the roof were used. The new batteries have given additional running time for the custodians in the event of low solar incidence.

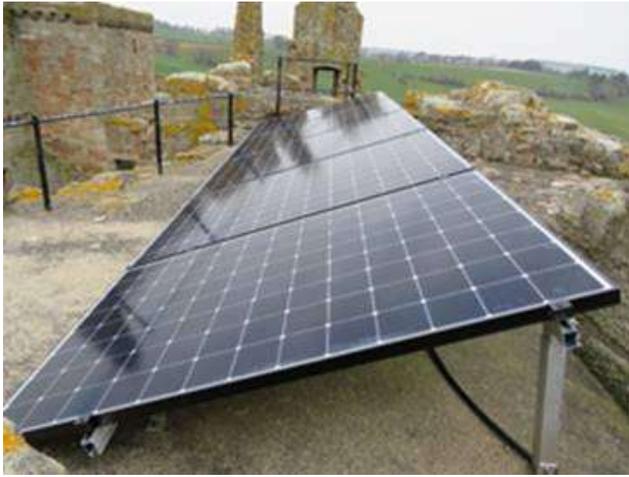
View of the panels on one of the towers ©
HES
