St. Franziskus Church - Ebmatingen, Switzerland

Photovoltaic roof-integrated system

ENERGETISCHE SANIERUNG KIRCHE ST. FRANZISKUS EBMATINGEN

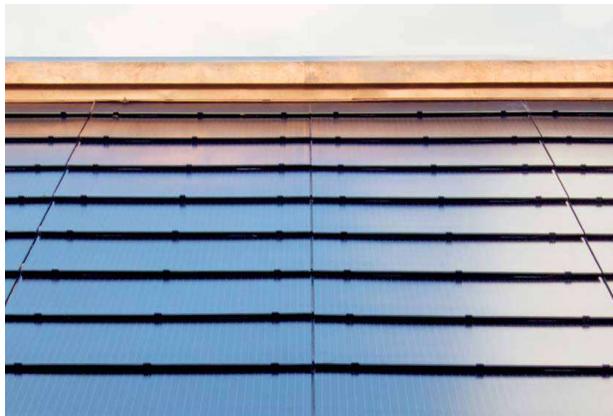
PV panels ©Studer

The solar photovoltaic integrated system and solar thermal PVT is well integrated in the complex surface of the existing roof. It complies with the geometric and spatial and construction compatibility criteria required by current regulations for the integration of solar systems in historic buildings (grouping, coplanarity with the roof slope, respect for the eaves lines and roof edge, joint precision, etc.). The aesthetic, material and color compatibility with the existing roof is optimal because it respects the original colour of the roof. The reflection rate is slightly higher with respect to the original roof tile that has been replaced. The final result is very good and well-integrated.

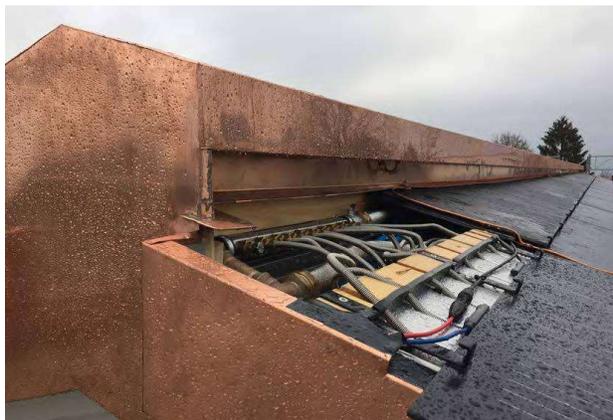
PV panels ©Studer

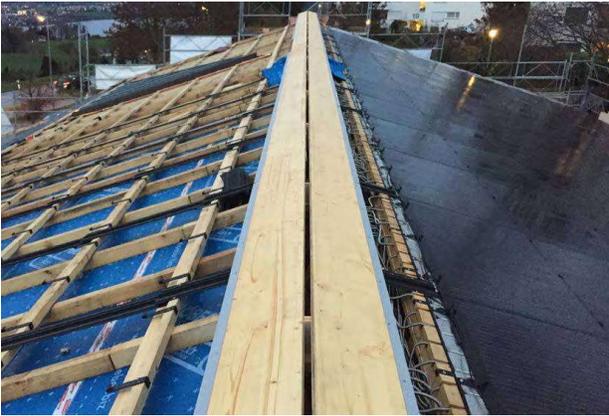
PV panels ©Studer
