Hof Neuhäusl

Cellulose for log Wall

Walls

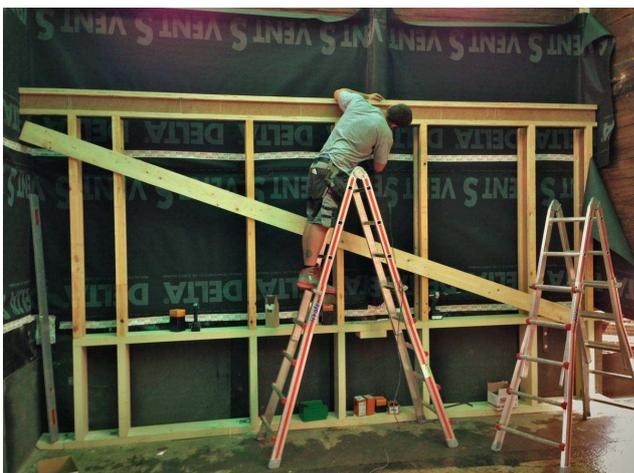
Cross section of the wall build-up, available pictures of the solution:

Black wind paper and frame construction for the OSB panels © DI Hans Peter Gruber

A possible solution to refurbish a wooden block wall to passive house standard is to apply a 22 cm thick cellulose insulation. The insulation is blown into the cavity between the stock log wall and the internal wooden construction. In order not to create any cavities in the insulation layer and to avoid subsidence of the insulation afterwards, it is important to blow the cellulose with sufficient pressure. The inner end of the hollow box is formed by an OSB board (Norbord), which also has the function of an airtight layer and a vapour control layer. The OSB board is screwed onto wooden T-beams (Steico company) and all butt joints are glued with airtight strips. With a board thickness of 15 mm, the OSB board achieves an Sd value of 3,0 – 4,5 m. It is accordingly a diffusion-limiting interior insulation system. A wooden formwork is assembled on the OSB board, which presents the visible surface in the interior area. In order to prevent the insulation from being flushed through, a wind paper is applied to the inside of the existing block wall.
