Single family House - Bern, Switzerland

Double-shell masonry wall

Walls

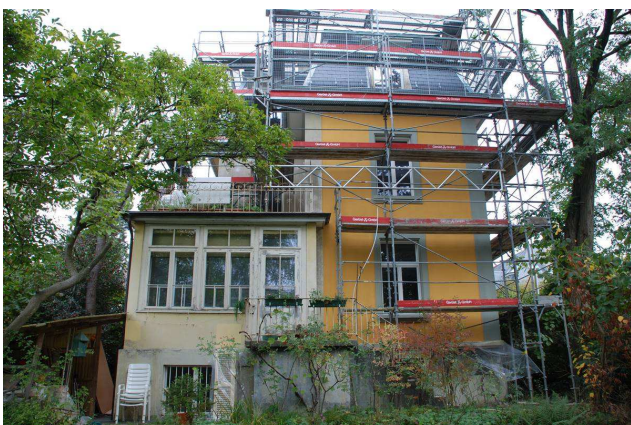
External renovation process © M. Hutterli

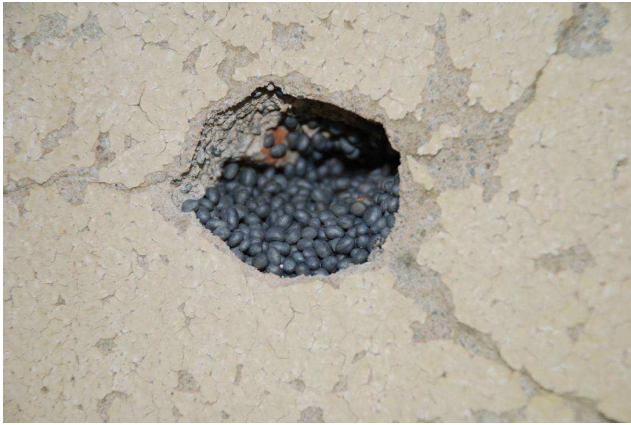
Double-shell blowing system with Isofloc H2Wall © M. Hutterli

The intervention maintains the original aesthetics of the wall and the increase in wall thickness is minimal. This way, the interior space of the building remains practically unchanged. Many houses built between 1900 and 1970 have cavity walls. The outer shell, usually a brick facade or plastered masonry, provides protection against the weather. Behind this there is a 40-100 mm cavity and the internal shell is usually the load bearing wall. A lot of valuable heat energy is lost via an un-insulated external wall. The retrofit solution used in this project, Isofloc H2WALL (isofloc® pearl,) is made from an EPS-based raw material granulate that has been refined with graphite specially developed for effective, cavity-free filling of double-shell masonry. For retrofitting of the double-shell wall construction, the EPS granulate is blown into the previously free air space through blow-in holes in the front wall shell and the openings are closed again with plaster or mortar of the same colour.

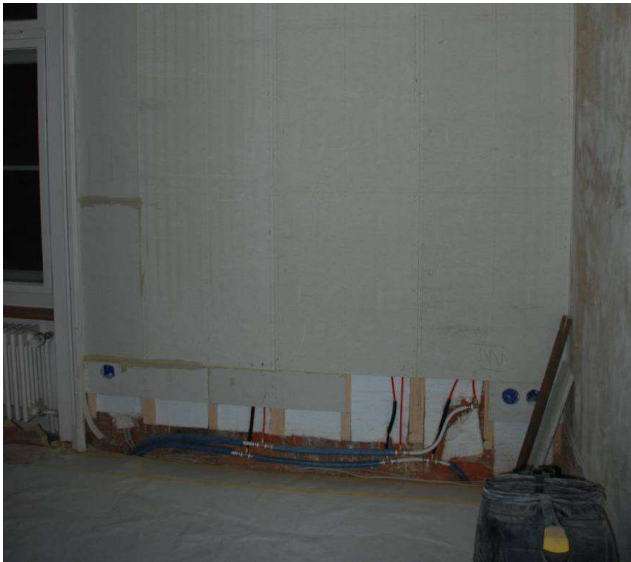
Internal wall intervention © M. Hutterli

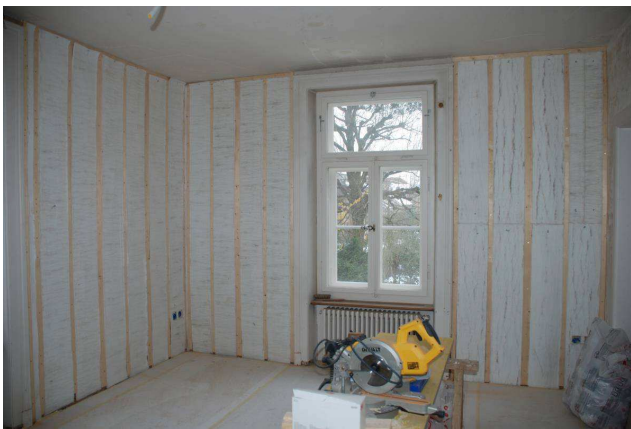
Internal intervention © M. Hutterli

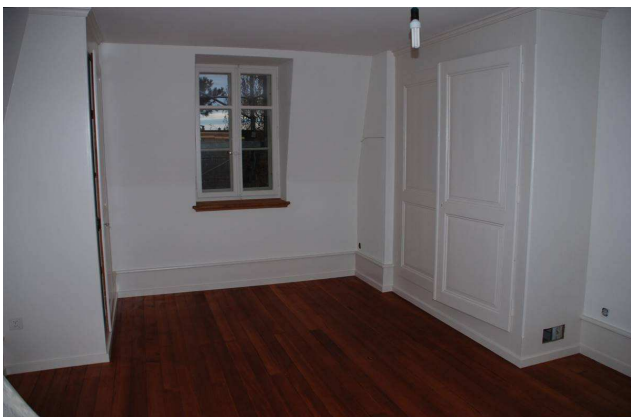
Internal wall after intervention © M. Hutterli

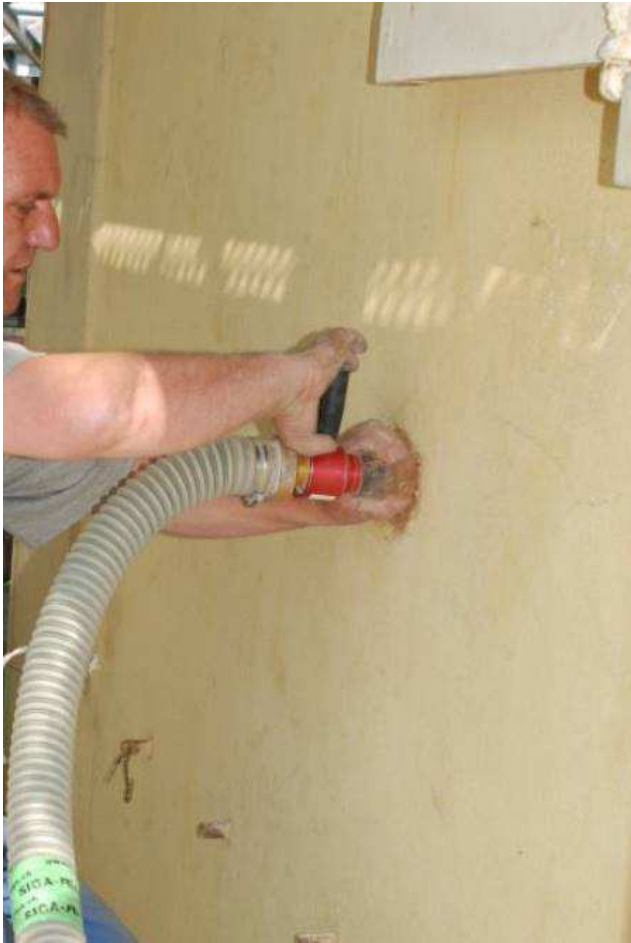
Intervention to improve thermal insulation of external walls. © M. Hutterli
